Hull Springs Farm, Westmoreland County

(Excerpt from "[Living Shoreline Sea Level Resiliency: Performance and Adaptive Management of Existing Breakwater Sites, Year 3 Summary](#)" Report)

9.1 Site Background

9.2 Site Performance

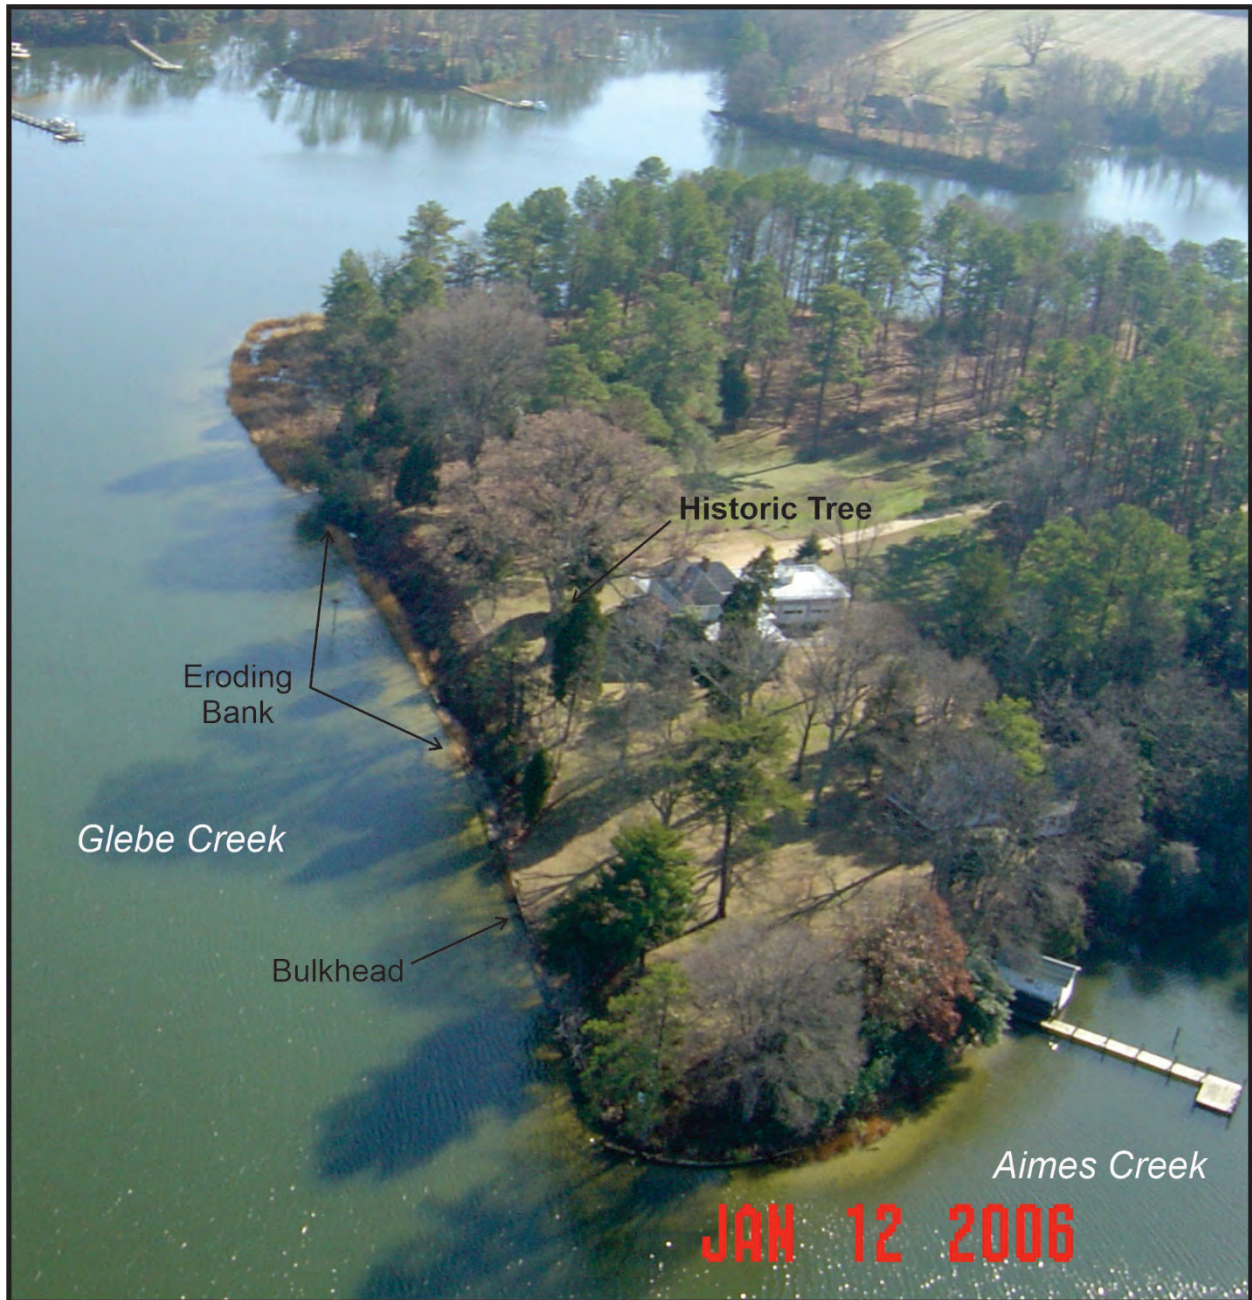
Figure 9-4. Aerial photo of the peninsula that Hull Springs Farm sits on. The shoreline has a high eroding bank and a failing bulkhead. The historic tree was a key part of the project design. Photo credit: Shoreline Studies Program, VIMS.

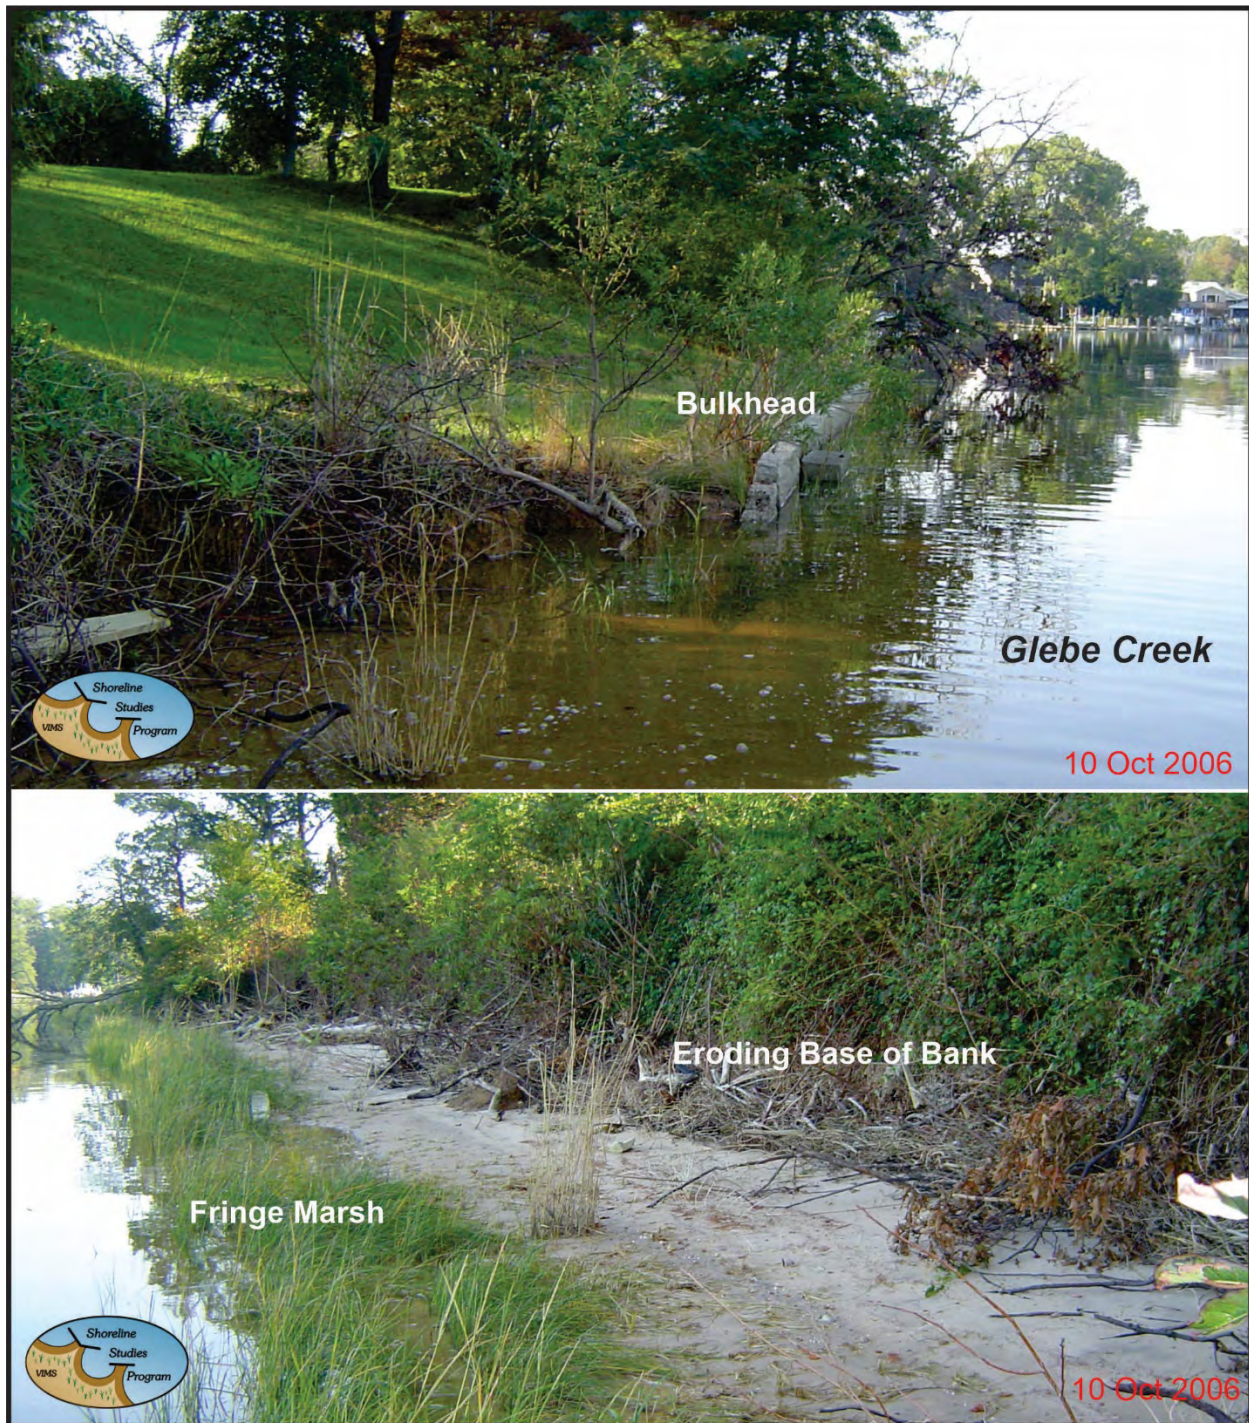
In 2006, the shoreline had an undercut high bank with an eroding base of bank and narrow fringe marsh adjacent to the farmhouse and 400-year-old historic oak tree (Figure 9-4). The bank decreases in elevation to the north and becomes a low bank with old concrete bulkhead (Figure 9-5). The end of the bulkhead is being flanked. This shoreline was part of the Lower Machodoc Shoreline Management Plan (Figure 9-6) created by Longwood University and the Northern Neck Planning Commission to provide guidance to homeowners on where living shorelines could be constructed. According to that document, the site qualified for an H-2 recommendation, marsh fringe with sill.

Due to Tropical Storm Ernesto in 2006, the base of bank was significantly impacted, and the nature of the long-term erosion was dramatically revealed. The wave-cut bank scarp from the storm was 6 ft high and eroded 1 to 2 ft in some areas (Hardaway et al., 2017). It was evident that the proposed sill was not sufficient for immediate protection of the base of bank since continued erosion would threaten the old oak tree on top of the bank. The design was modified to include a stone revetment in the vicinity of, and adjacent to, the old oak to ensure that the historic tree on top of the bank was not impacted by bank erosion during storms (Figure 9-9).

Figure 9-4. Ground photos of the Hull Springs Farm shoreline. Top: the western section of shoreline has a failing bulkhead; Bottom: Post Ernesto: the center section of the peninsula has an eroding base of bank and a fringe marsh. Photo credit: Shoreline Studies Program, VIMS.

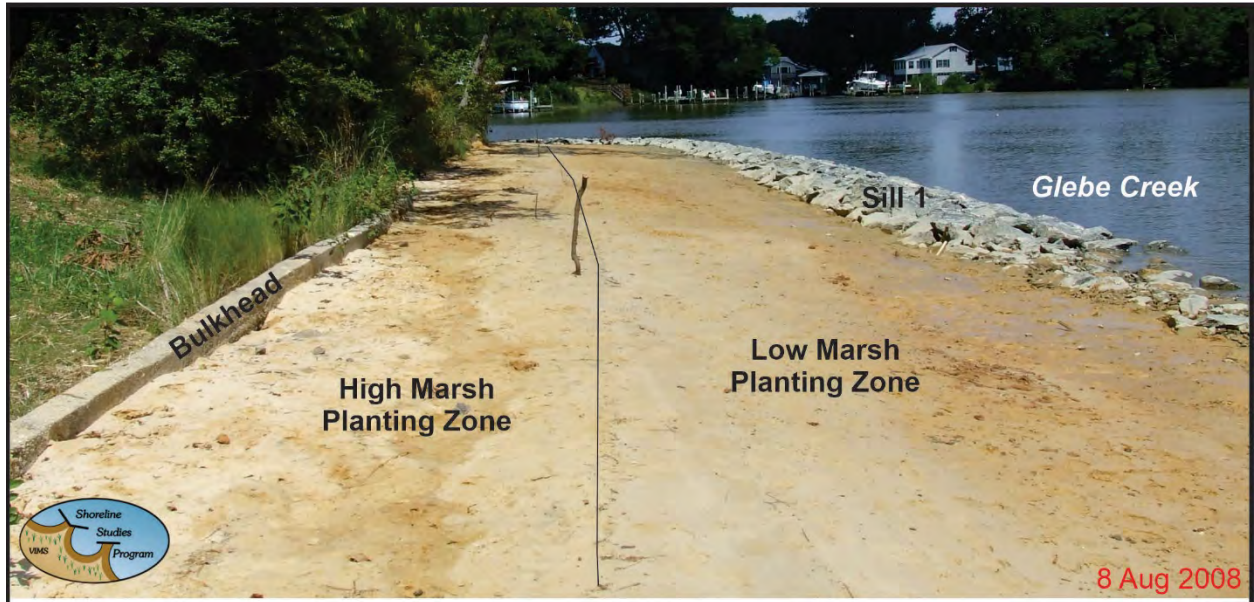
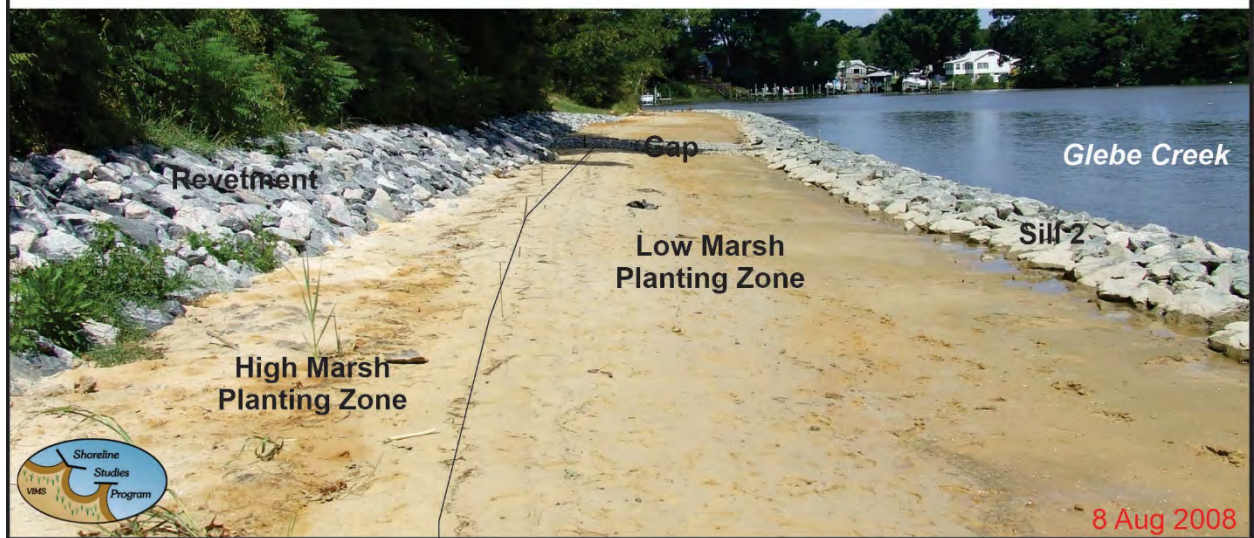
The Hull Springs Farm sill was built in late summer 2008 along about 300 ft of shoreline. It was built as designed with the sill built in front (waterside) of the revetment (Figure 9-10). The existing concrete bulkhead remained, and sand was filled to almost the top. The trees on the bank were limbed but not cut down. Low marsh (*Spartina alterniflora*) and high marsh (*Spartina patens*) grasses were planted on a 1.5 ft x1.5 ft spacing after the sand had a chance to equilibrate for several tidal cycles.

Figure 9-10. Post construction ground photos showing the low and high marsh planting zones. The marsh was planted soon after.

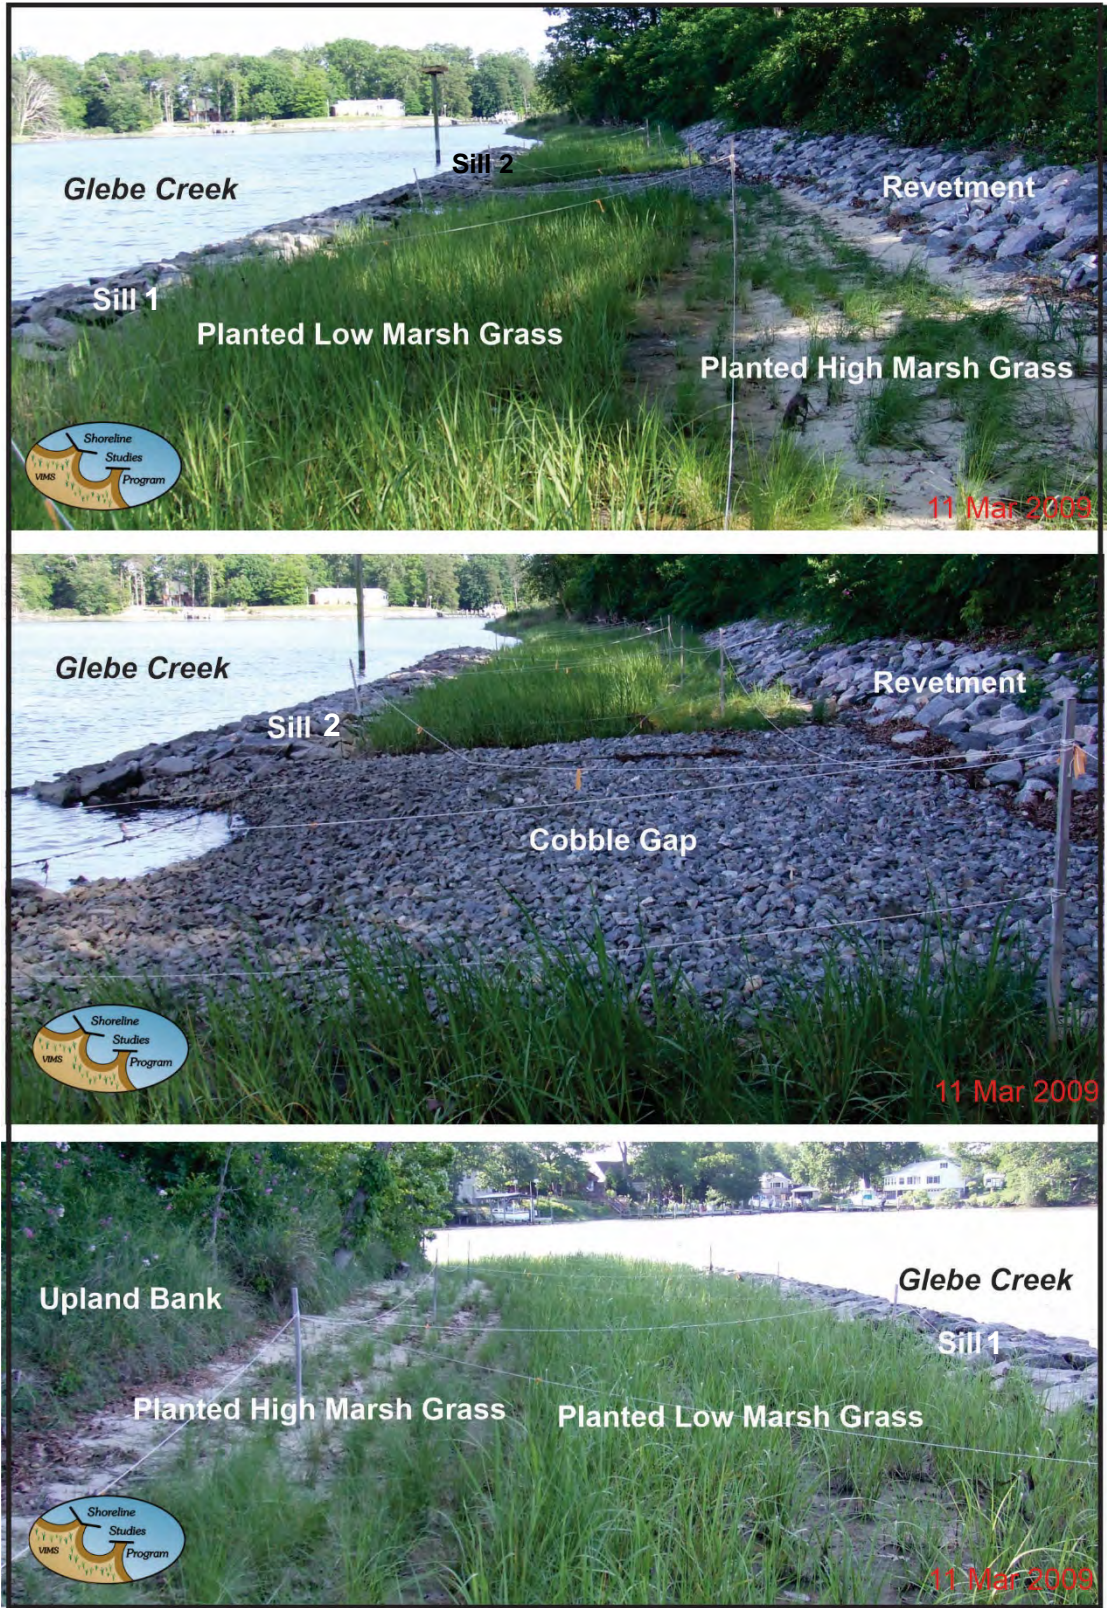
After about six months, the low marsh was growing well, but the high marsh was not as lush (Figure 9-11). The site was performing as designed six years after installation in 2015 (Figure 9-12). The low marsh behind sill 2 was lush. The bank had slumped covering the revetment, but it also was vegetated which provides additional protection. This historic tree, which was estimated to have started growing in 1595 CE, was well protected from erosion. The high marsh did not grow as well as the low marsh (Figure 9-13). Though scrub/shrub were starting to grow at the higher elevations, the *Spartina patens* that were planted were relatively sparse. This is likely due to overhanging trees that were beginning to shade the high marsh. At this point in time, no *Phragmites* occurred at the site.

Figure 9-11. Hull Springs Farm living shoreline after about 1 year. The elements were constructed as designed, and the low marsh has filled in well. Photo credit: Shoreline Studies Program, VIMS.

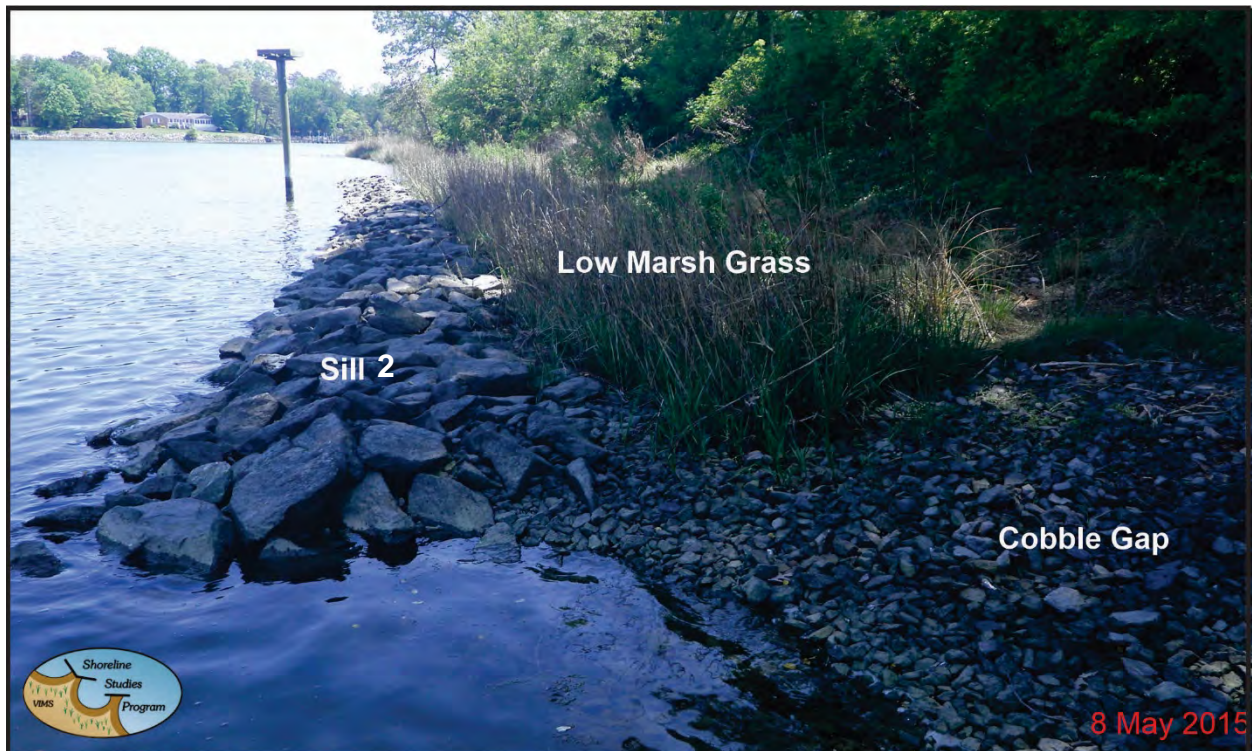
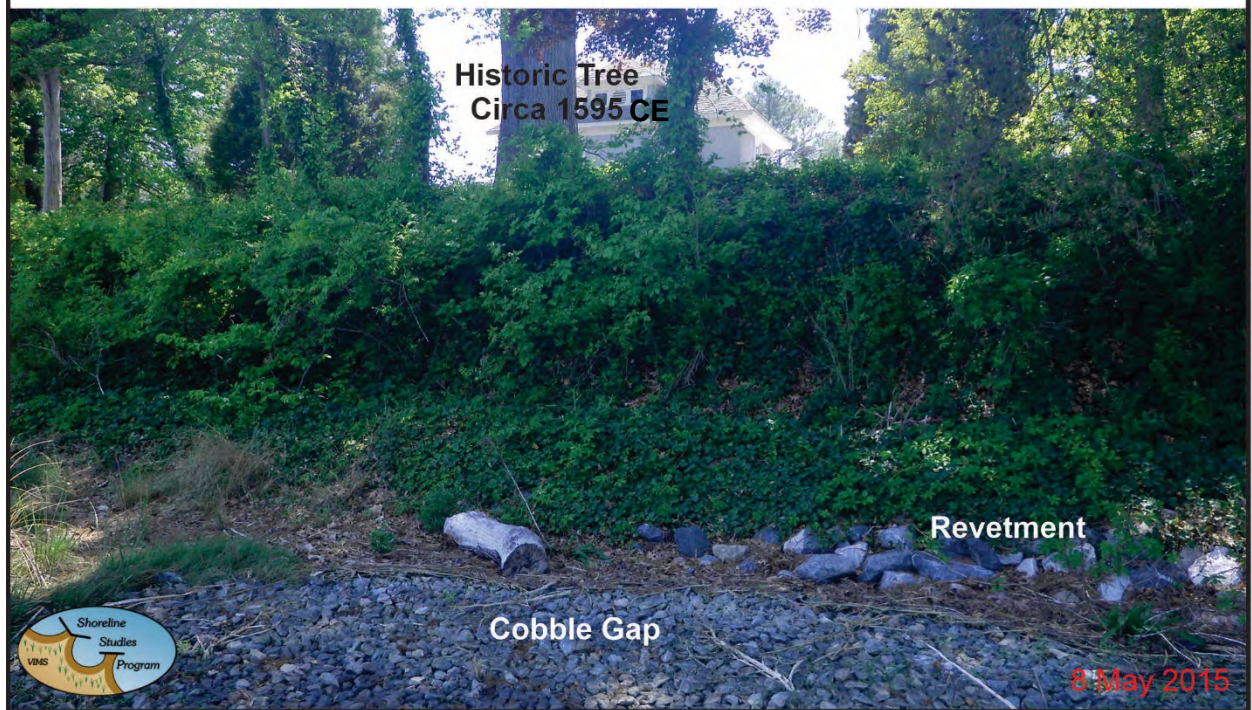
Figure 9-12. Hull Springs Farm about 6 years after construction. Top: Sill 2 has lush low marsh behind the structure, but the high marsh is not as vegetated. Bottom: The bank has slumped over the revetment. The sediment is vegetated which adds additional stability to the bank to protect the historic tree. Photo credit: Shoreline Studies Program, VIMS.

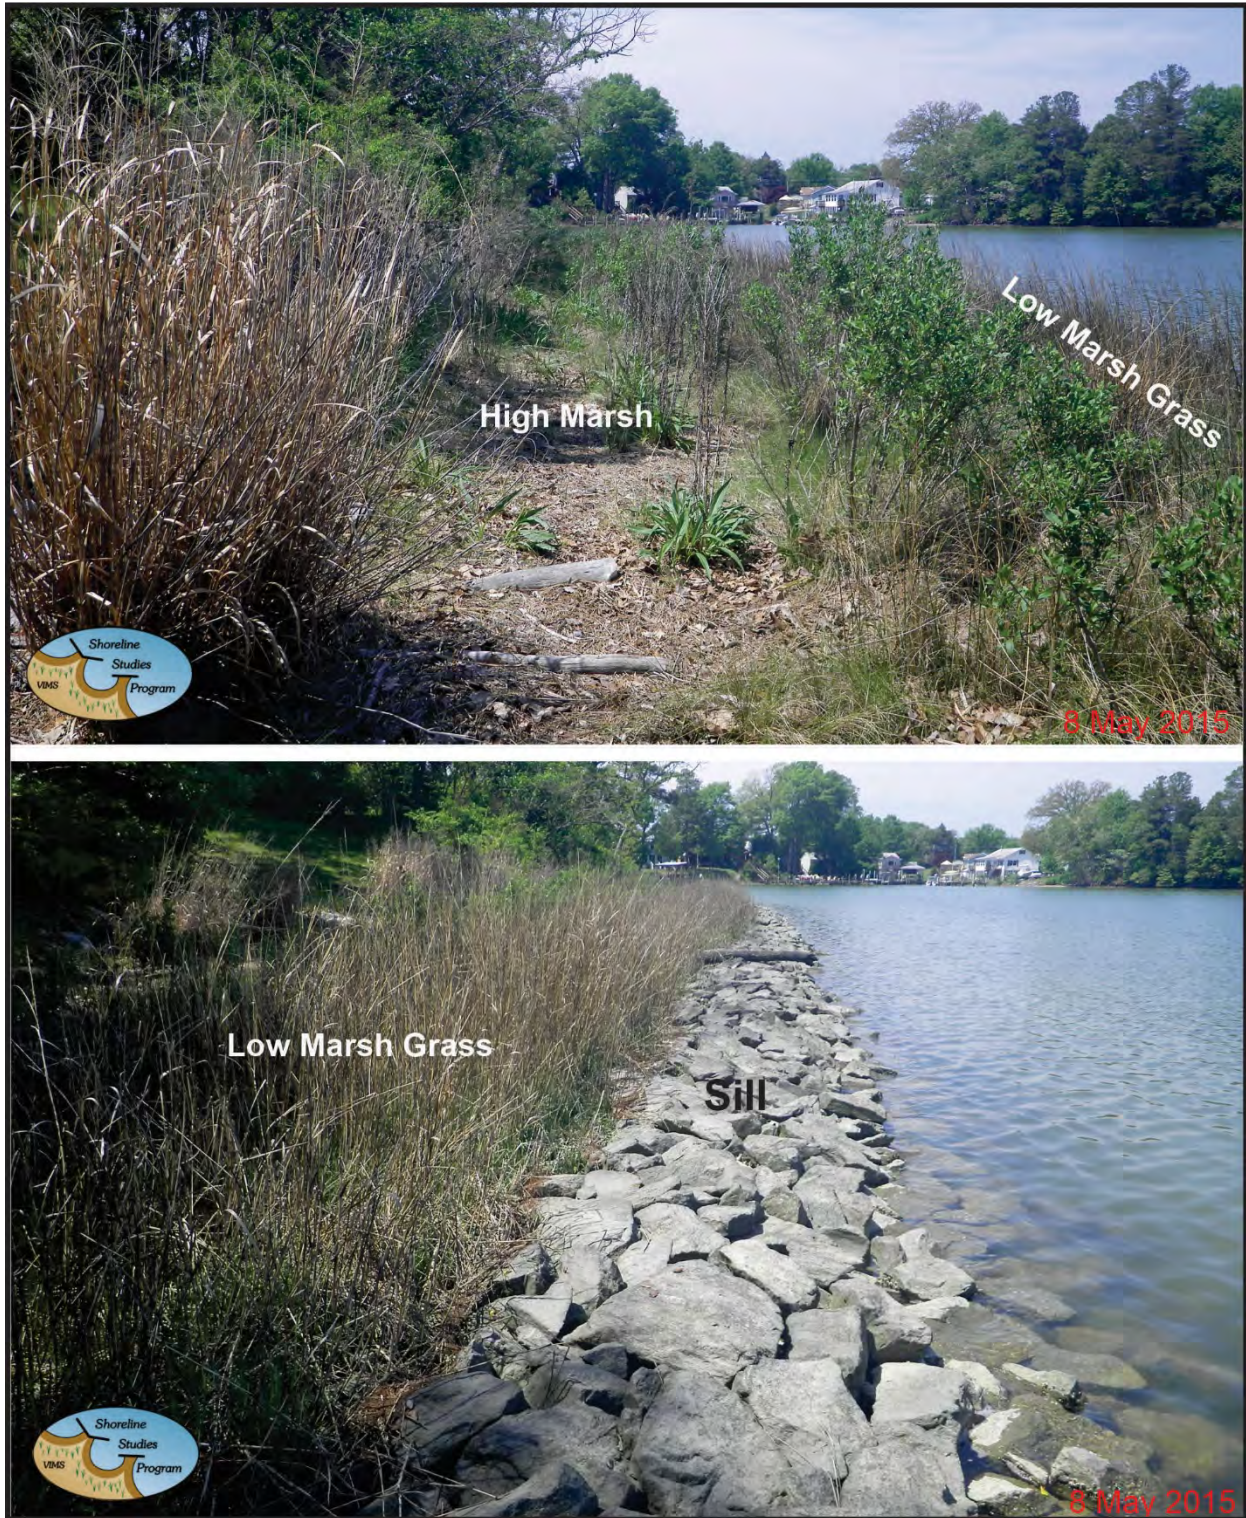
Figure 9-13. Hull Springs Farm about 6 years after construction. Top: The backshore where the upper marsh should be does not have as much grass vegetation as the low marsh. Bottom: The low marsh is doing well behind sill 1. Photo credit: Shoreline Studies Program, VIMS.

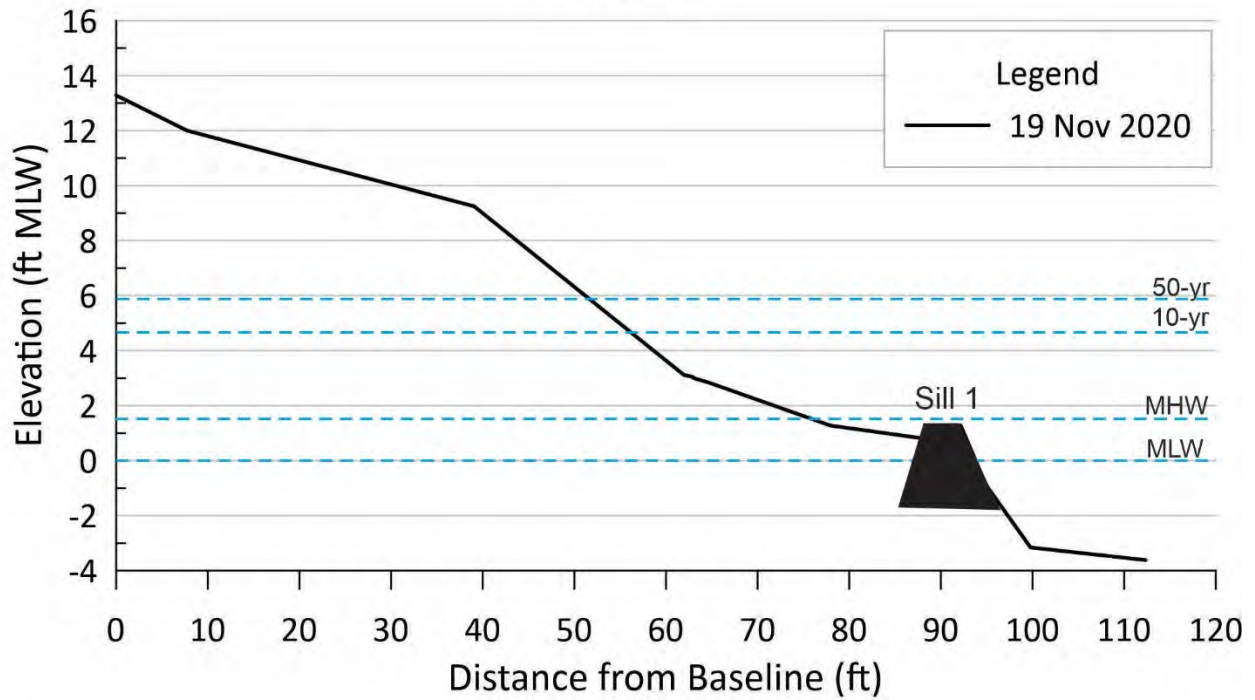
Profile 98

Figure 9-15. Profile cross-sections from Hull Springs Farm taken on 19 November 2020. Profiles 98 and 181 cross Sill 1.

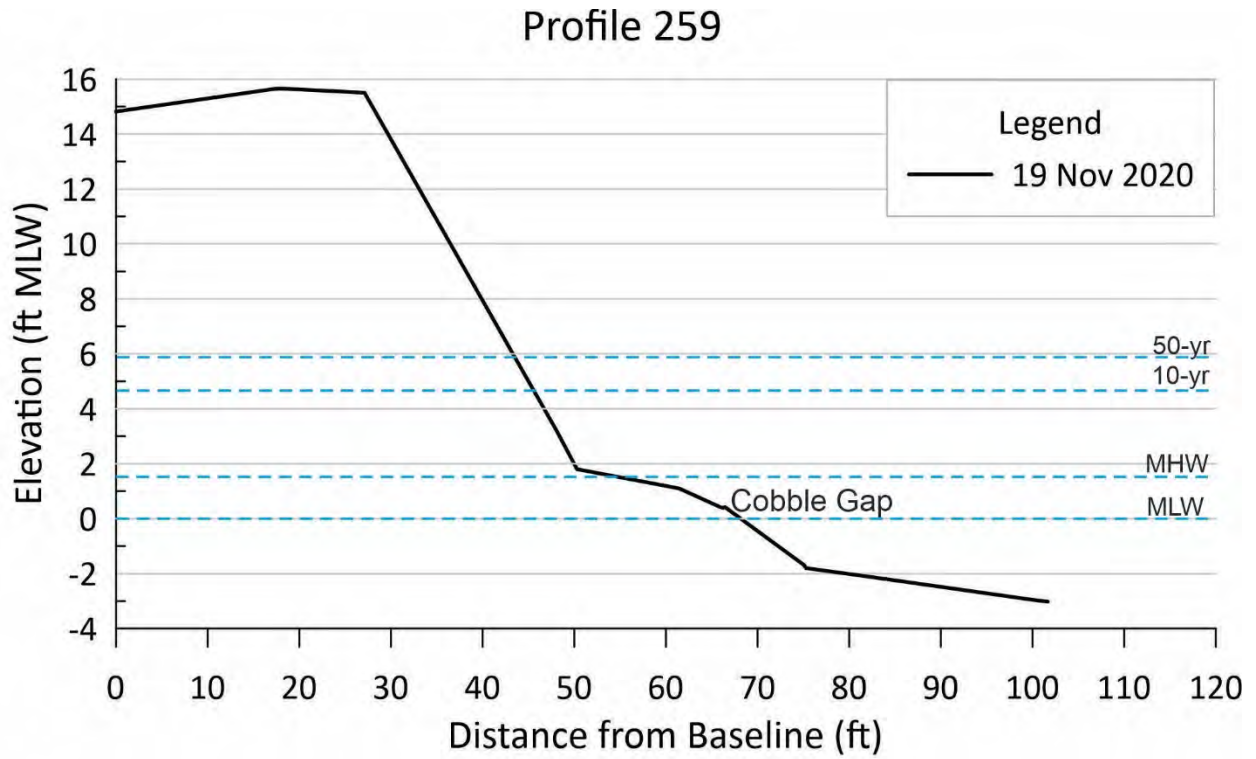
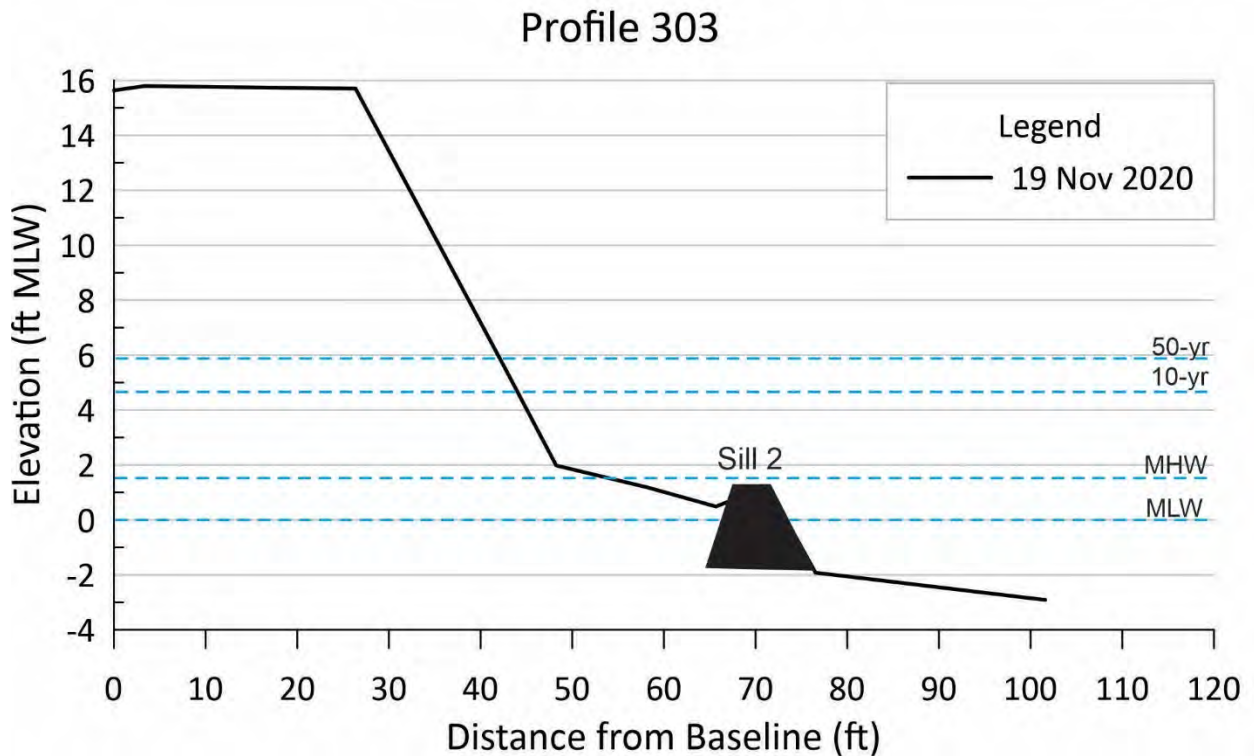
The shoreline was surveyed on 19 November 2020 (Figure 9-14). No previous data could be located. The cross-sections are shown, and the revetment is highlighted in teal on the map. Generally, the position of MHW is closer to the base of the upland bank and MLW is on the sill structures. Figures 9-15 and 9-16 show the cross-sections of the profile data. Profiles 98 and 181 cross Sill 1. The bank height ranges from 11-13 ft MLW. The sill was built to design with a crest elevation of about +1.8 ft MLW (Figure 9-15). Profile 259 crosses the shore through the cobble gap (Figure 9-16). The base of the revetment is at about +2 ft MLW. The bank is at about +16 ft MLW behind Sill 2.

Figure 9-16. Profile cross-sections from Hull Springs Farm taken on 19 November 2020. Profile 259 crosses the cobble gap between Sills 1 and 2 and Profile 303 crosses Sill 2.

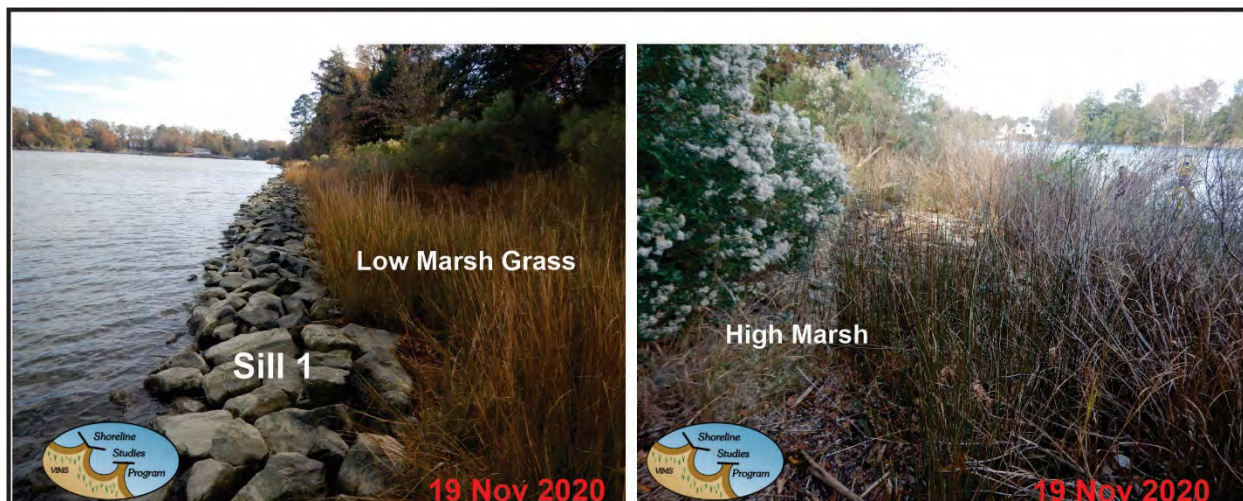
Twelve years after installation, the sill structure remains intact (Figure 9-17). In addition, the low marsh has nearly 100% coverage behind sill 1. The upper limit of *S. alterniflora* was measured at about +1.5 ft MLW. Two other marsh species have colonized into the site, black needle rush (*Juncus roemerianus*) and three-square bulrush (*Schoenoplectus pungens*). The upper limit of black needle rush was measured at +1.6 ft MLW. Tide range is 1.8 ft MLW. The high marsh has more vegetation than in previous years behind sill 1, but bare spots occur. The scrub/shrub has grown into the backshore in this area. The cobble gap is vegetation free and allows access to the water (Figure 9-18). However, with time, the invasion of *Phragmites* along parts of Sill 1 and Sill 2 forced the Longwood University to initiate an eradication program which killed much of the healthy marsh grass too (Figure 9-19). The backshore is bare in areas as the native vegetation tries to recolonize those areas. Still, most of the marsh away from this area is intact.

Figure 9-17. Ground photos of the site after 12 years showing the low marsh and high marsh areas of the sill. Photo credit: VIMS, Shoreline Studies Program.

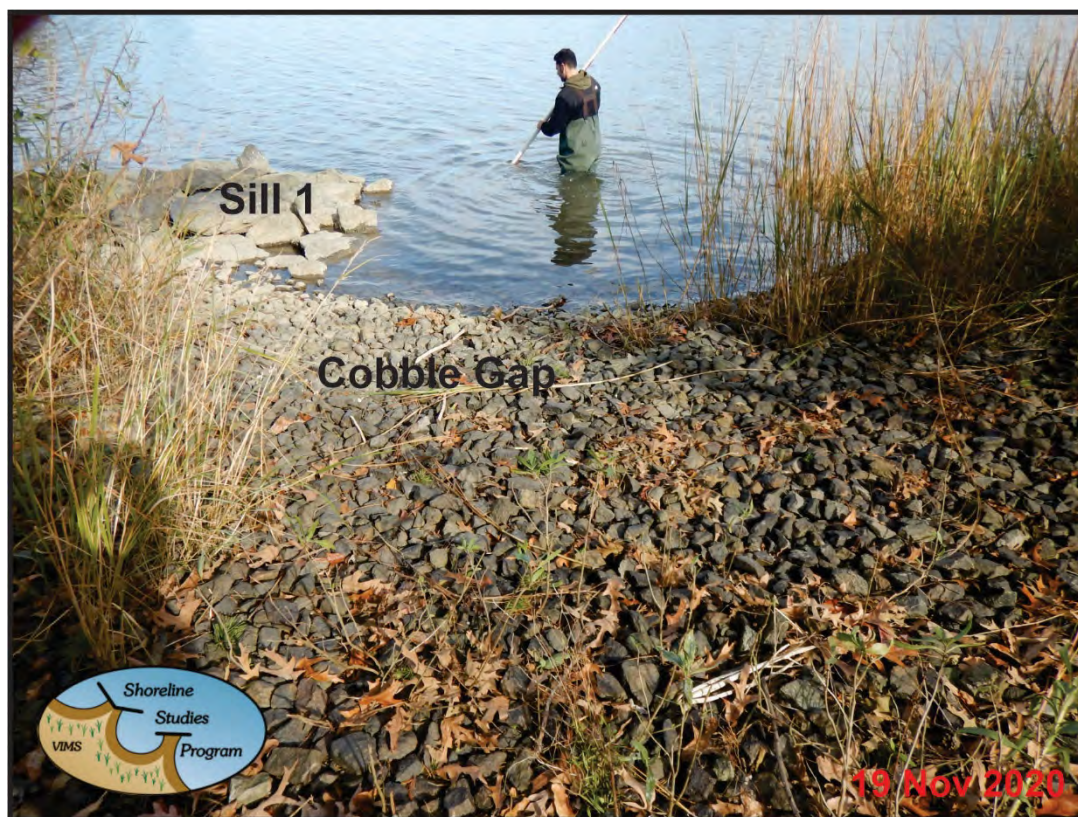
Figure 9-18. Ground photo of the site showing the cobble sill gap. Photo credit: VIMS, Shoreline Studies Program.

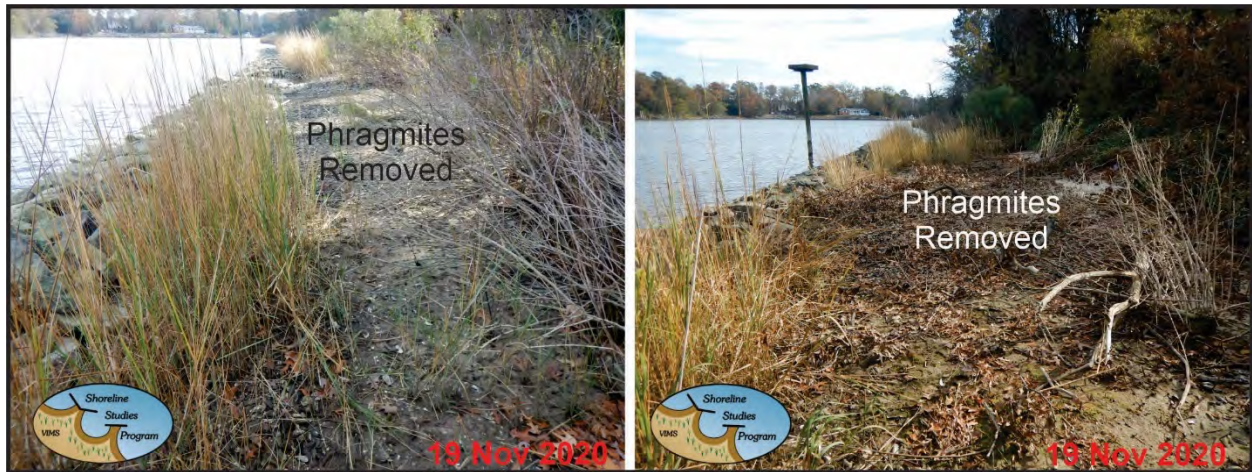
Figure 9-19. Bare spots behind the sill where *Phragmites* was eradicated and native grasses have not grown back yet. Photo credit: VIMS, Shoreline Studies Program.
