4.2 Occohannock on the Bay

(Excerpt from “[Living Shoreline Sea Level Resiliency: Performance and Adaptive Management of Existing Sites](#)” report)

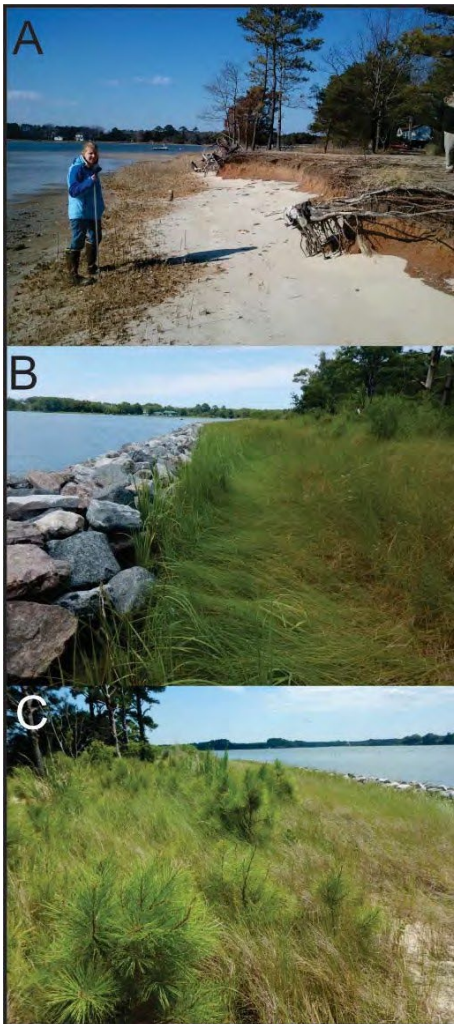
The project was built in 2013. Reach 1 is shown in Figure 4-2-4A pre-construction in 2013, and after 5 years Figure 4-2-4B. Full marsh growth is evident. Small pine trees and salt bush are pioneering the backshore along the low bank (Figure 4-2-4C). Reach 2 shown right after planting and after 5 years (Figure 4-2-5A and 4-2-5B). Blue arrows indicate small tidal creek channel still functioning. Abundant oyster growth on rocks and fish utilization are seen along entire project (Figure 4-2-5C). Reach 3 is seen before construction, after construction and after 5 years in Figures 4-2-6A, B, and C, respectively. The low marsh section has developed “bare” areas where the *S. alterniflora* is absent even with some maintenance planting. A reduction in grade is expected. However, non-vegetated wetlands are still very valuable habitat and the high marsh and shore protection terrace is still very much intact. As this site matures pioneering small pines are becoming abundant and should be thinned to reduce the potential for shading the erosion resistant high marsh “turf”.

Figure 4-2-4. Photos of reach 1 at Occohannock on the Bay A) before installation (April 2013), B) after 5 years (July 2018), C) after 5 years, the backshore is being colonized by trees.

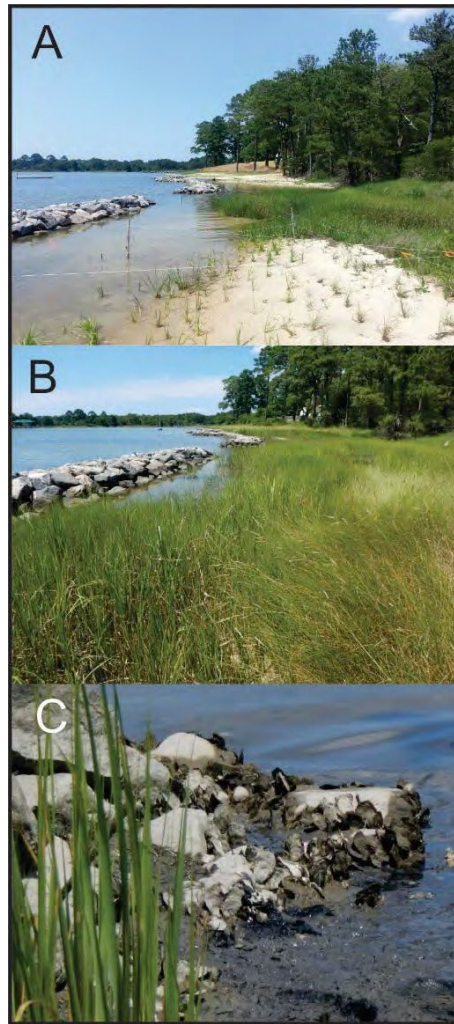
Figure 4-2-5. Photos of reach 2 at Occohannock on the Bay A) after planting (May 2013), B) after 5 years (July 2018), C) after 5 years there is abundant oyster growth around the end and outsides of the rock sills.

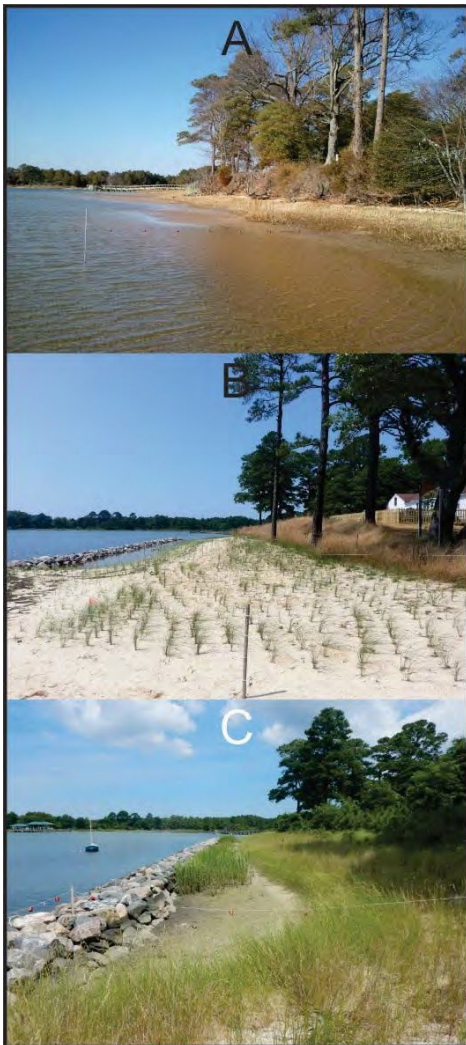
Figure 4-2-6. Photos of reach 3 at Occohannock on the Bay A), before construction (March 2013), B) after planting (May 2013), C) after 5 years.

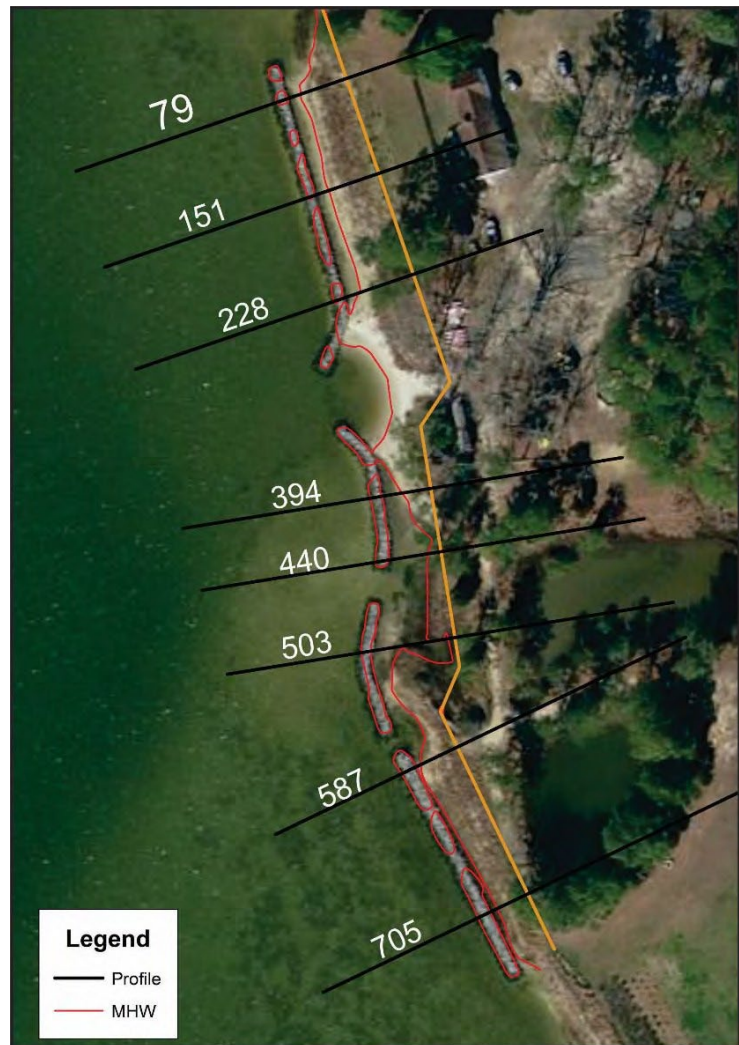
Survey data shows Reach 1 sill (ZZ) with elevated substrate from the sand fill in sections P587 (Figure 4-2-7 and Figure 4-2-8). The upland bank edge was graded slightly to the back of the sand fill. Reach 2, Sill 1 shows the mouth of the tidal creek has shifted and deepened slightly (P503). The tidal creek flat behind sill # 3, P440 has remained relatively stable transitioning to the sand fill going north, P 394. Reach 3 sections P151 and P79 show the graded bank and wide stable sand fill.

Figure 4-2-7. Location of cross-sectional profiles at Occohannock and the 2018 surveyed position of mean high water.

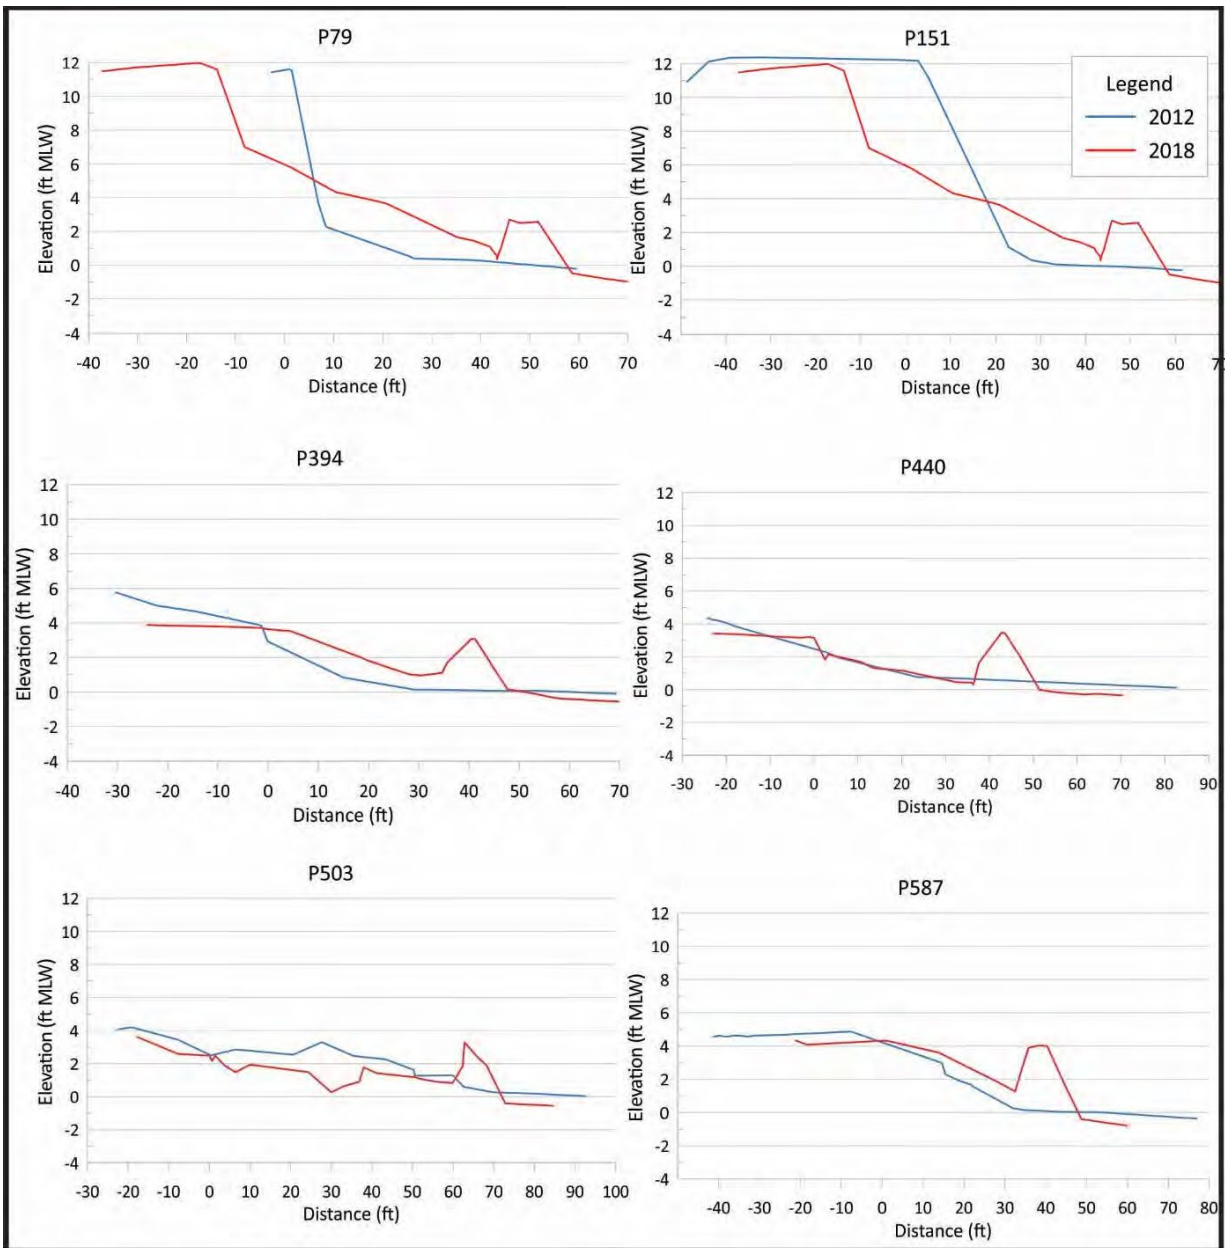
Figure 4-2-8. Cross-sectional profiles at Occohannock taken before the living shoreline project was installed and in 2018.
