Hull Springs Farm, Westmoreland County

(Excerpt from "[Living Shoreline Sea Level Resiliency: Performance and Adaptive Management of Existing Breakwater Sites, Year 3 Summary](#)" Report)

9.1 Site Background

9.2 Site Performance

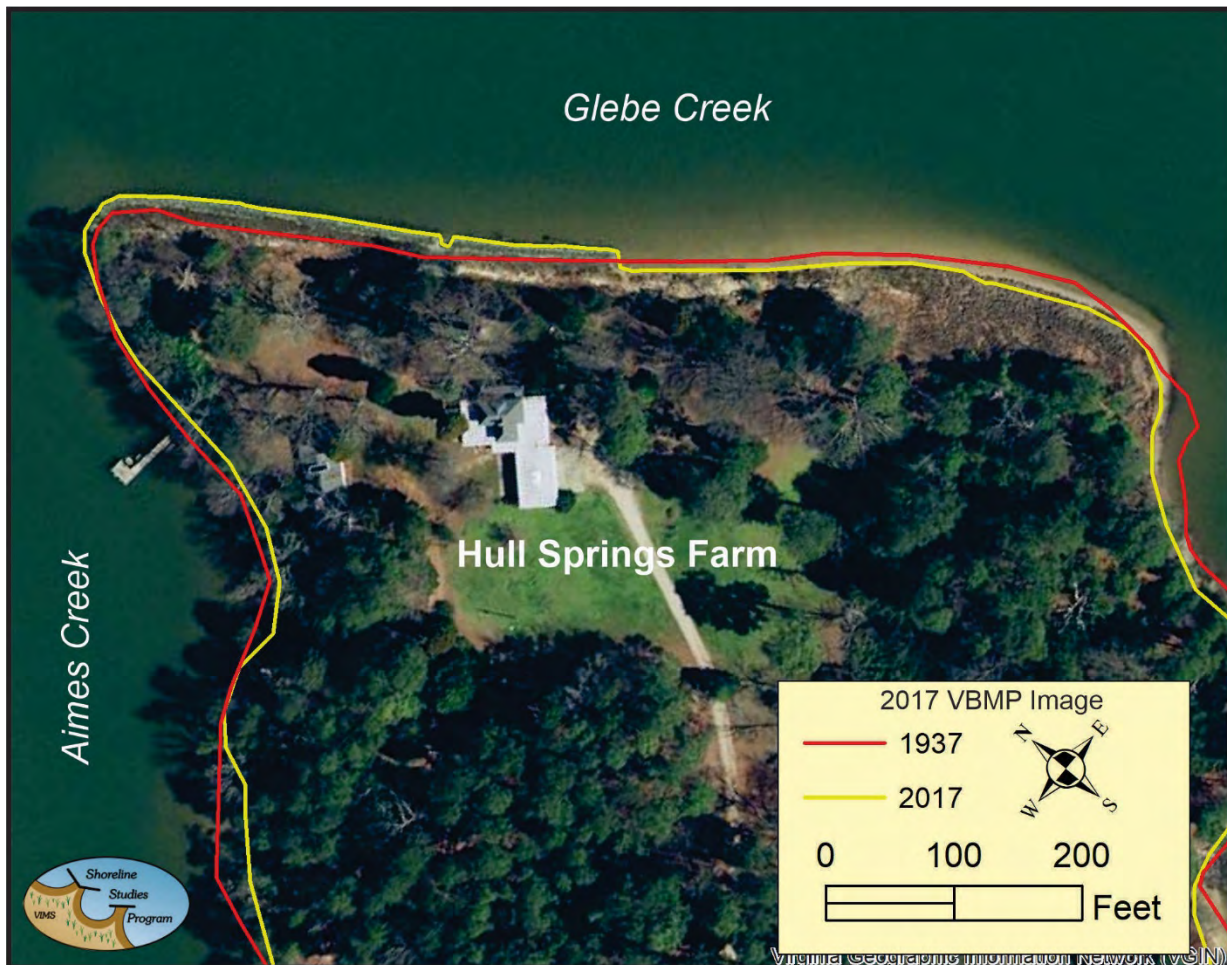
Figure 9-2. Shore change between 1937 and 2017 at Hull Springs Farm. Digitized shorelines from the SSP shoreline change database.

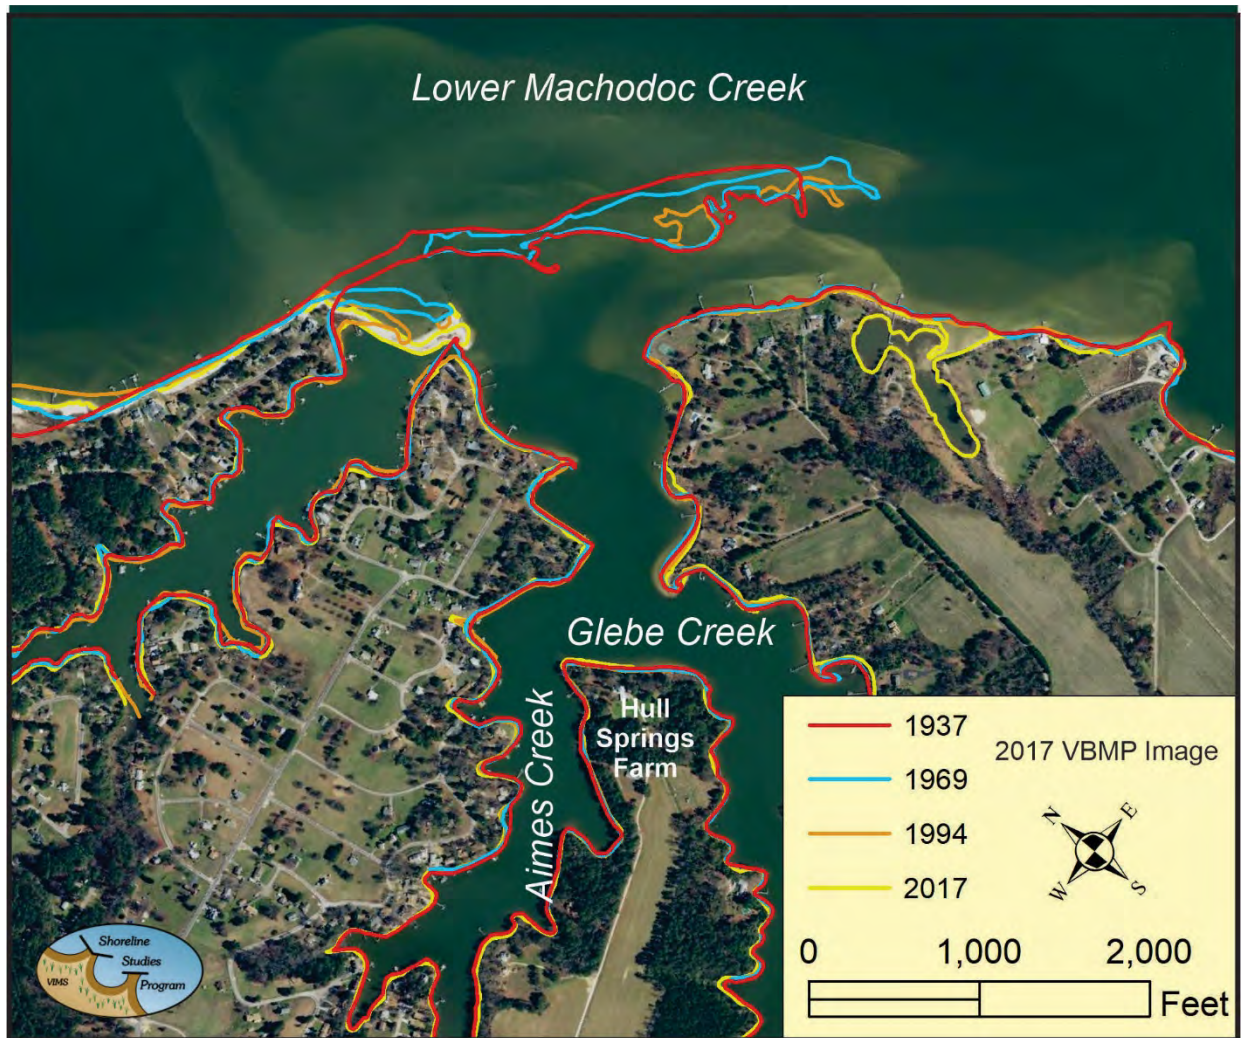
Figure 9-3. Digitized shorelines in 1937, 1969, 1994, and 2017 along the Lower Machodoc Creek and tributaries. The sand spit that occurred across the mouth of Glebe Creek in 1937 and 1969 had eroded away by 1994 increasing the fetch at Hull Springs Farm. Digitized shorelines from the SSP shoreline change database.

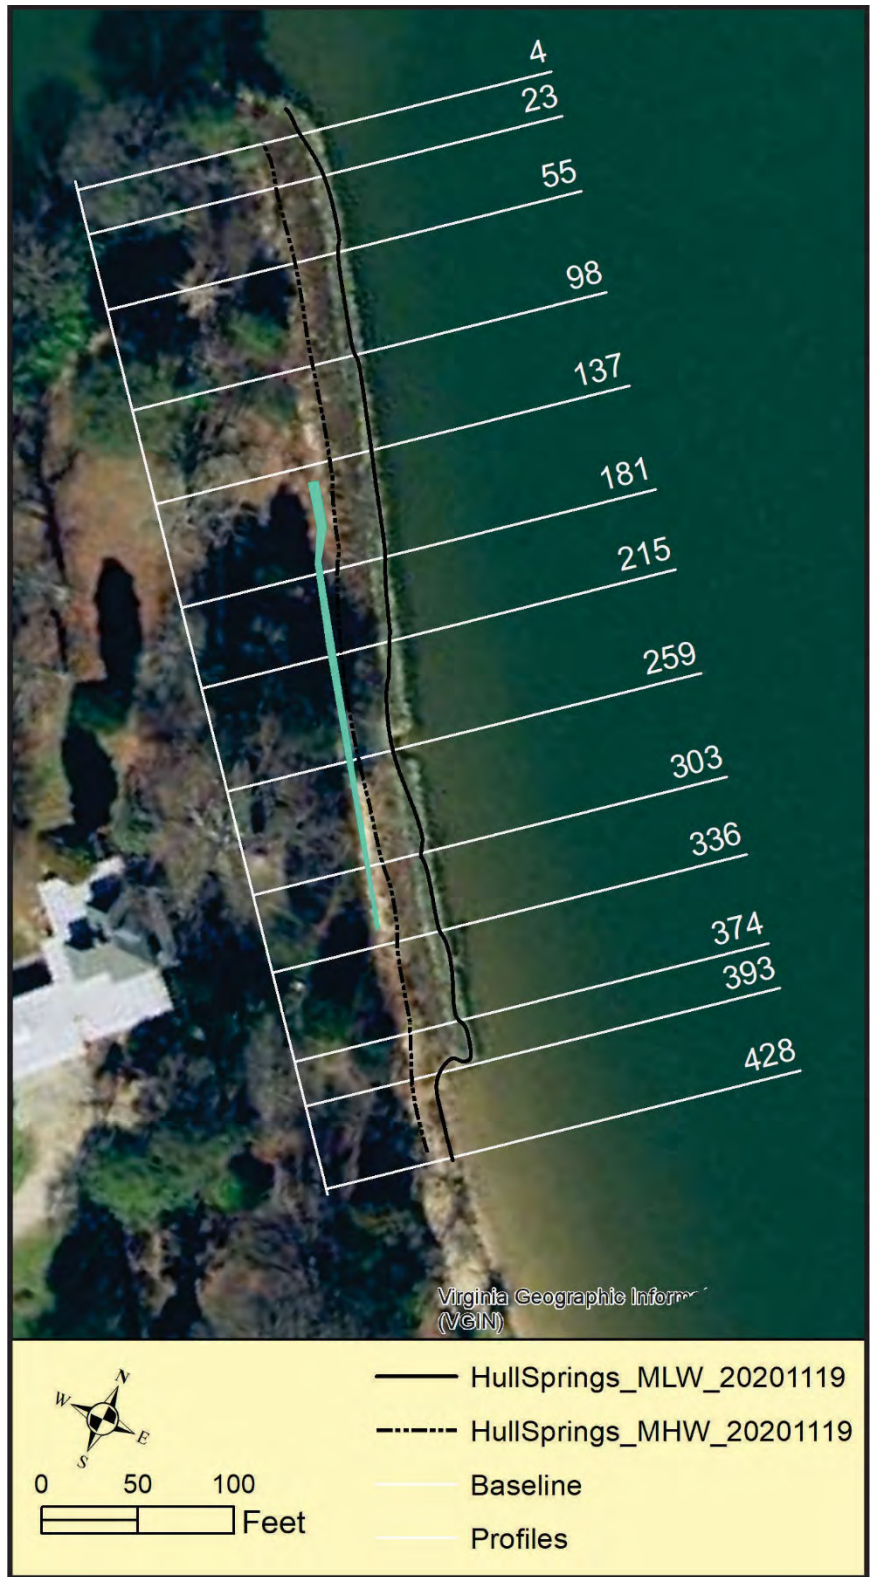
The shoreline was surveyed on 19 November 2020 (Figure 9-14). No previous data could be located. The cross-sections are shown, and the revetment is highlighted in teal on the map. Generally, the position of MHW is closer to the base of the upland bank and MLW is on the sill structures. Figures 9-15 and 9-16 show the cross-sections of the profile data. Profiles 98 and 181 cross Sill 1. The bank height ranges from 11-13 ft MLW. The sill was built to design with a crest elevation of about +1.8 ft MLW (Figure 9-15). Profile 259 crosses the shore through the cobble gap (Figure 9-16). The base of the revetment is at about +2 ft MLW. The bank is at about +16 ft MLW behind Sill 2.

Figure 9-14. The position of MHW and MLW from the 2020 survey. Also shown are the profile cross-section locations. The location of the revetment is highlighted in green.
