4.2 Occohannock on the Bay

(Excerpt from “[Living Shoreline Sea Level Resiliency: Performance and Adaptive Management of Existing Sites](#)” report)

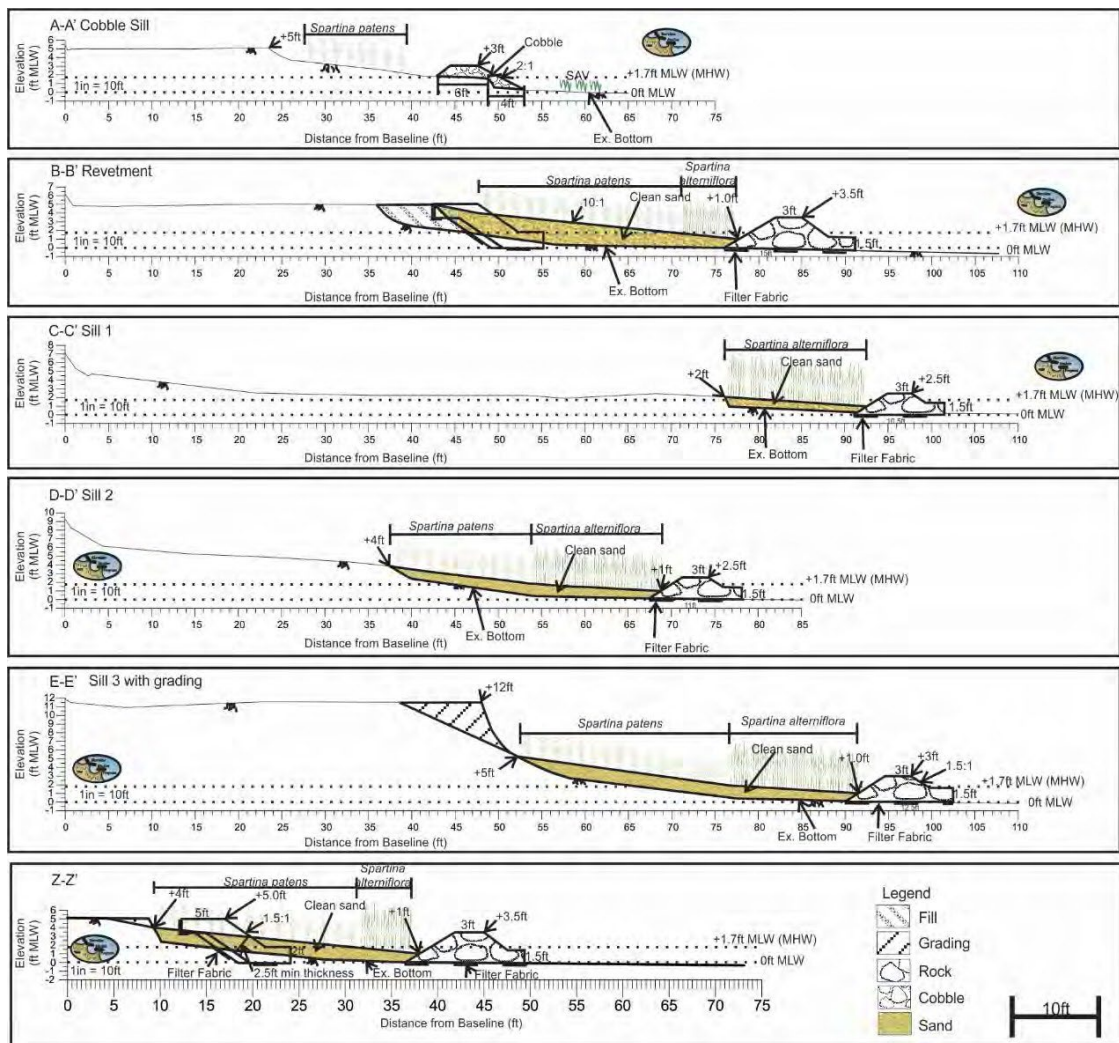
Figure 4-2-3. Typical cross-sections for Camp Occohannock living shoreline.

1. Along Reach 1 the original revetment was replaced with a 185-foot-high sill Section BB and ZZ (Figure 4-2-3) to protect the actively eroding upland and access path. Sand fill intersected the sill at +1.0 ft MLW and graded to a +4 ft at the low upland bank.

2. Reach 2 begins with Sill #1 then a gap (Bay B) for the tidal creek, Section CC. Sand fill went to edge of low eroding marsh scarp. Beyond Bay A, Sill #2 continues along the remaining marsh shore transitioning to the low upland banks, Section DD.
